BOP CHANGE OUT ON A BLOWING GAS WELL IN EGYPT

LOCATION: EGYPT

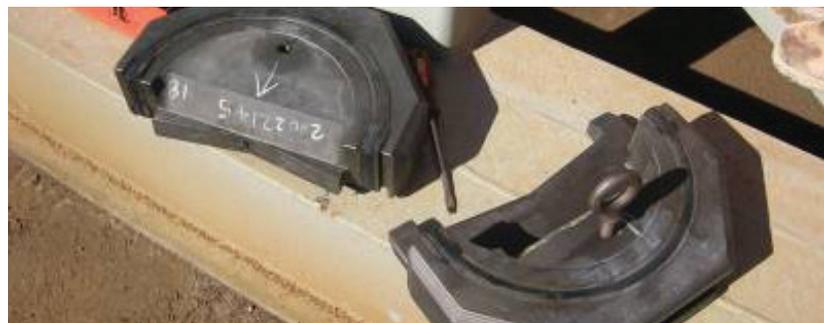
With all preparations complete, the pipe was sheared off. Flow was immediately visible from the bell nipple after closure of the blind/shear rams. The rig tongs were rigged up to a crane, by way of a sheave, and the pipe was rotated to ensure a complete shear was present. The CT equipment and pipe stub were raised above the blinds by the bulldozer and the blinds were closed. All flow was diverted to the flare pit.
