SHALLOW GAS RIG FIRE IS CONTROLLED AND CAPPED

LOCATION: MISSISSIPPI

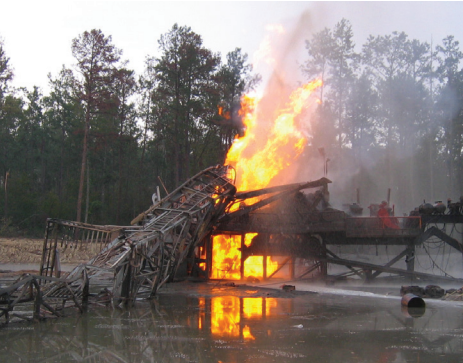
This well was drilling ahead at a depth of 4100' with 2000' of surface casing set. The rig hit a shallow gas zone and took a kick, resulting in a blowout and fire. The well was also producing a large volume of salt water. The drilling crew abandoned the rig and no injuries were sustained during the disaster. The rig and BOP stack were engulfed in flames.

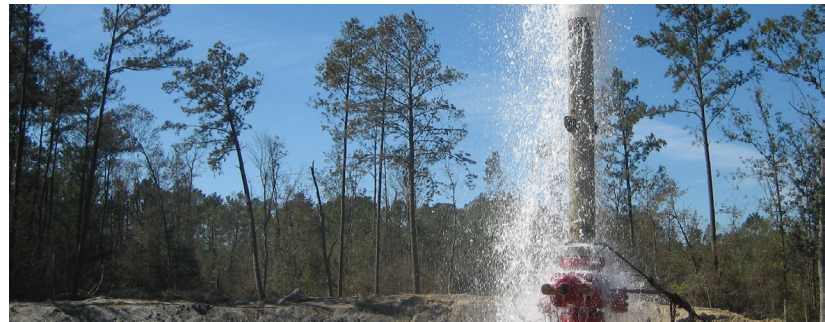
work being performed at the time. CWC tied onto the substructure with the crawler crane and two bulldozers. The sub was hoisted high enough to clear the BOP stack and then pulled off of the well. The bolts on the bell nipple were severed and the bell nipple stripped over the remaining kelly. At this time it was noticed that the wellhead was damaged during the initial blowout. The damage could not be repaired, so a complete re-head was required. The old head was cut off and an 11" 5M slip-on head was lowered over the flow and secured to the surface casing.

The well was capped with a spacer spool, flow cross, single blind ram and a Venturi tube. The capping stack was nipped up, and an 8 5/8" diverter line was rigged up to the flow cross outlet. The HCR valve was open and the well was partially diverted to the reserve pit. The pump iron was pressure tested and then the blind rams were closed. CWC began to pump 12.0 ppg kill weight mud down the well and simultaneously shut the HCR valve to proceed with a bullhead kill. A total of 250 barrels of mud were pumped to kill the well. The well was monitored and deemed static. CWC was released from location.
